RE: First Quarter 2010 Progress Report  
RCRA Corrective Action  
Allison Transmission, Speedway, IN  
USEPA ID Nos. IND006413348 and IND000806828

ATTACHMENT A  
FIRST QUARTER 2010 PROGRESS REPORT  
PERFORMANCE-BASED RCRA CORRECTIVE ACTION  
ALLISON TRANSMISSION  
JANUARY 1, 2010 TO MARCH 31, 2010

Subject:  
February 3, 2010 - AOI 51 Remediation System Incident

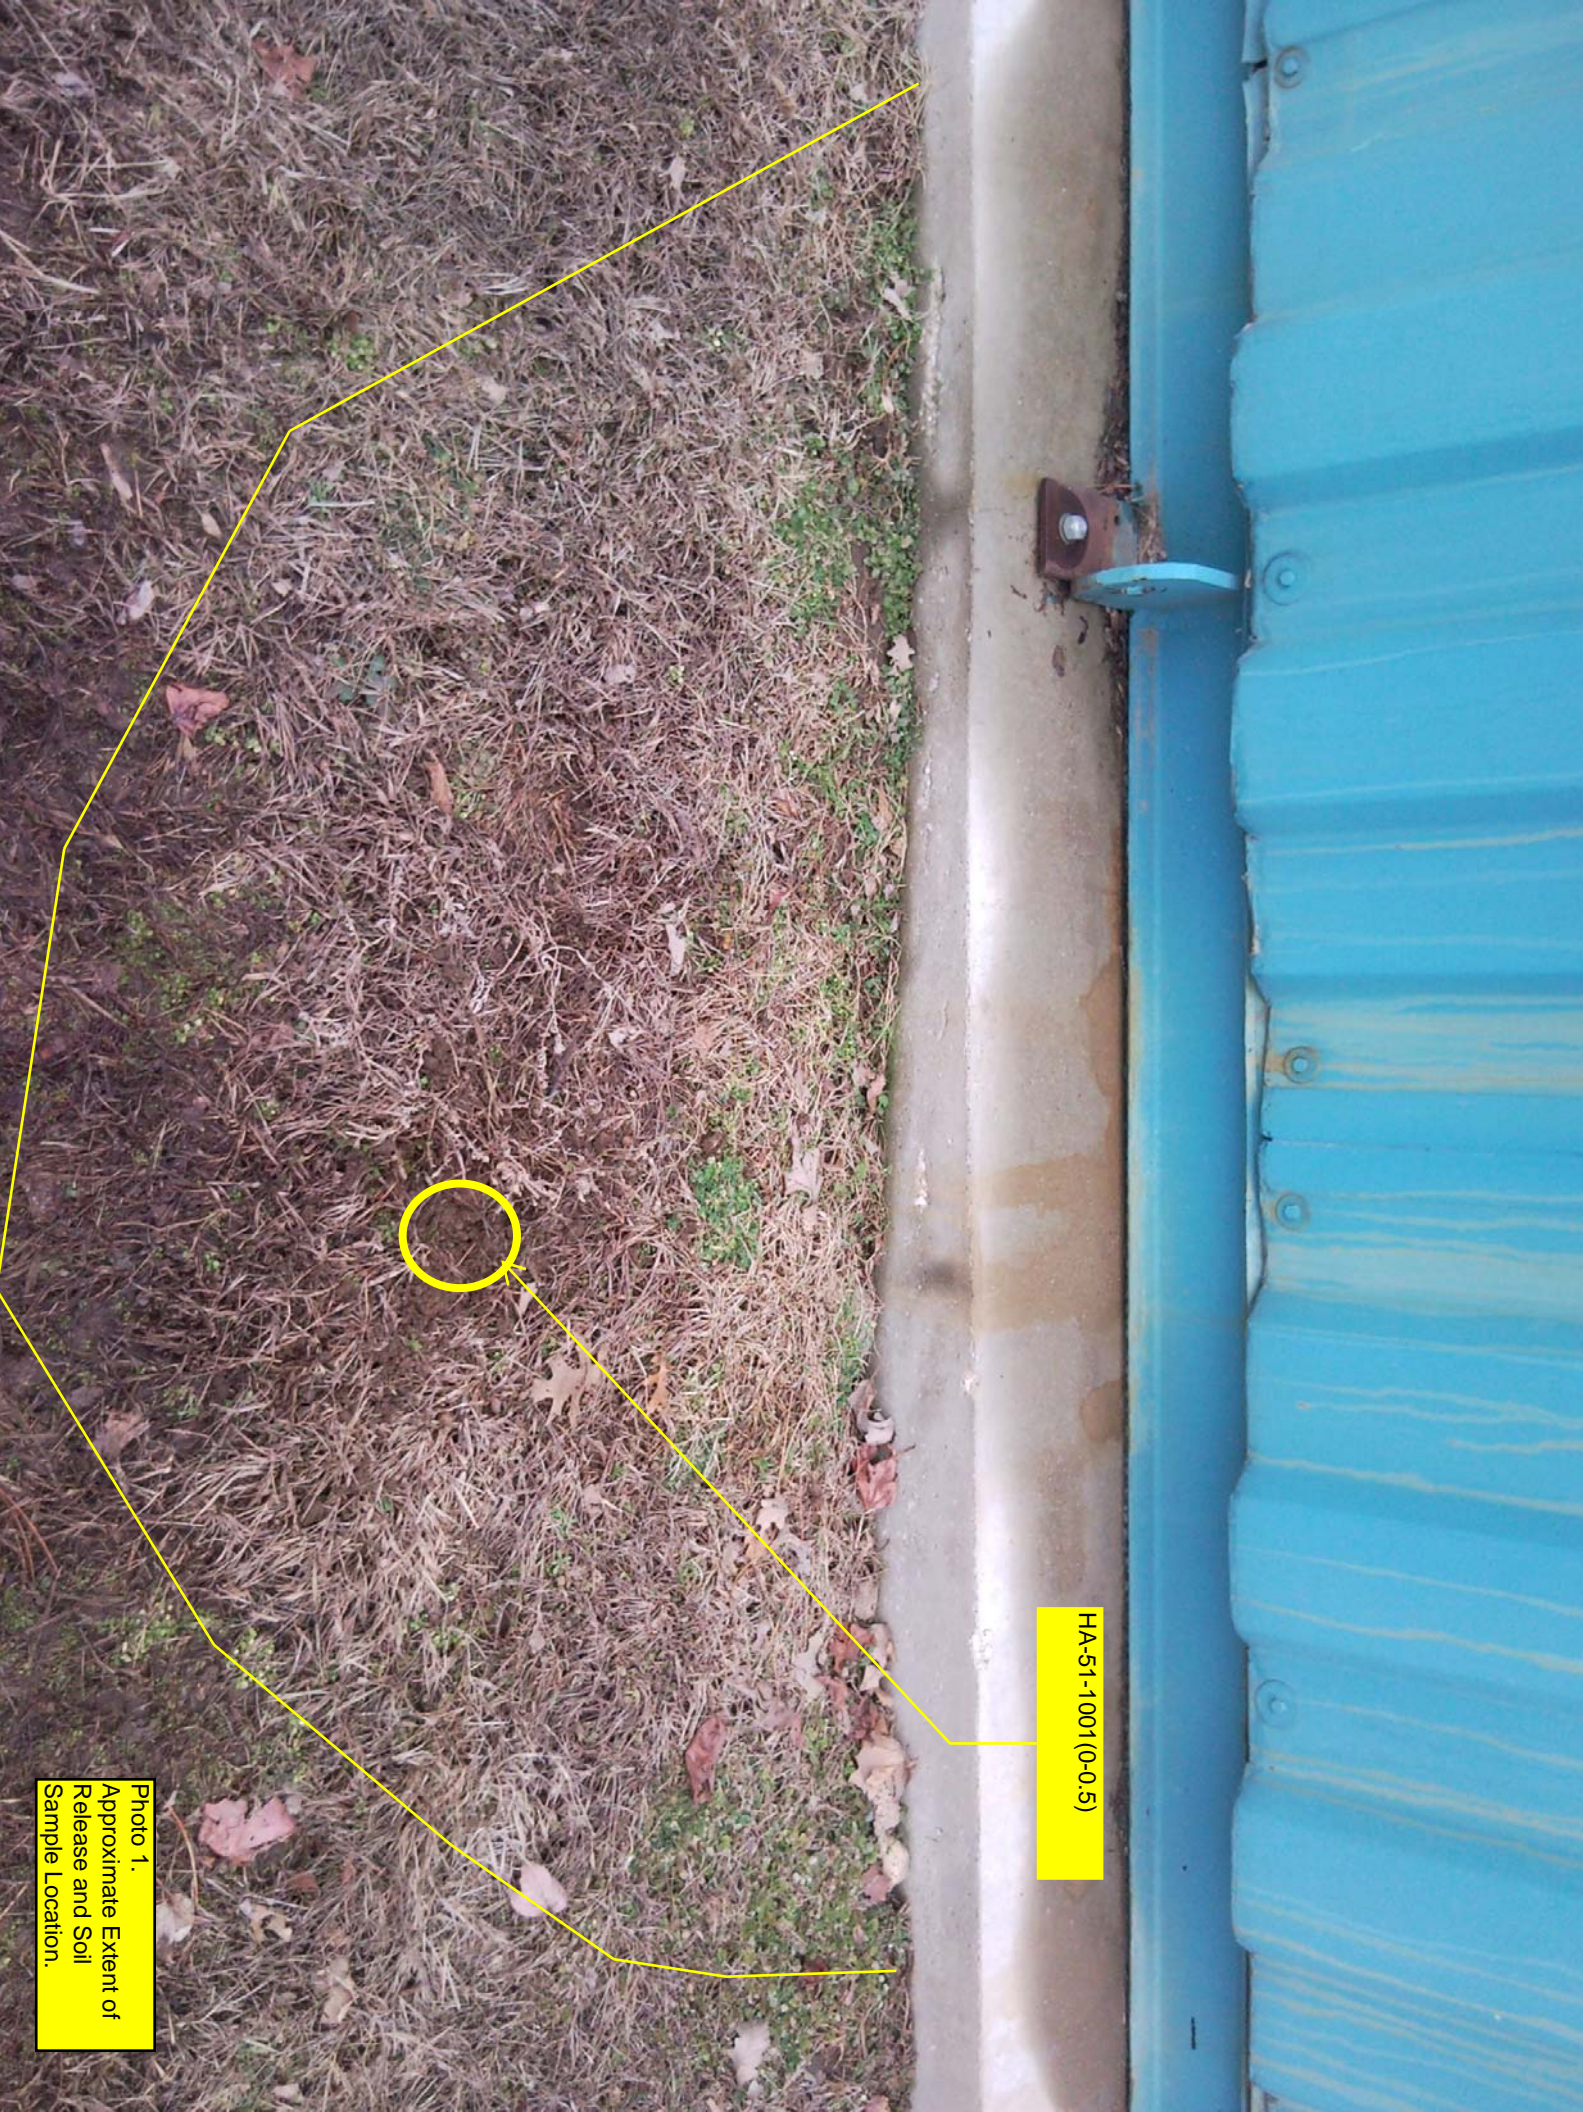
HA-51-1001(0-0.5)

At 09:27 on Wednesday morning, February 3, 2010, water was being emitted from the equalization tank (EQ) air vent at the Former Degreaser Area (AOI 51) Groundwater Remediation building. Upon receipt of this information from Allison Transmission, Inc. (ATI) personnel, ARCADIS immediately performed a remote login to the system and activated the emergency-stop (e-stop) button. At the time of e-stop activation, continued discharge was observed from the east building, so it was unknown at the time if the e-stop did work correctly and the remaining discharge was gravity feed/excess pressure in the line, or that the e-stop was ineffective and continued pumping was observed. An ARCADIS representative was on-Site within minutes and evaluated the situation. No standing water was observed; however, a wet area of approximate dimensions 3'x3' was noted (see Photo 1, attached).

ARCADIS collected a surface soil sample (0 – 0.5' below ground surface), from the area of interest identified above on February 4, 2010 (see Photo 1, attached). The soil sample was submitted to Pace Analytical in Indianapolis, Indiana and analyzed for total compound list (TCL) volatile organic compounds (VOCs) via USEPA Method 8260.

PCE was the only VOC detected in the surface soil sample. The concentration of PCE in the soil was 16.4 µg/kg. Table 1 below provides the site-specific screening criteria for PCE which have been reviewed by US EPA Region 5. Based on the comparison of PCE to the site-specific screening criteria, the concentration of PCE in the soil did not exceed; therefore, additional action was not warranted to address the soil.

Photo 1.  
Approximate Extent of  
Release and Soil  
Sample Location.
